REPORT No 11890

NACE TM 0284

EVALUATION OF PIPELINE AND PRESSURE VESSEL STEELS FOR RESISTANCE TO HYDROGEN-INDUCED CRACKING

Program: SQ-0038

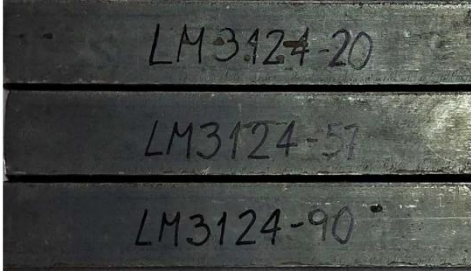
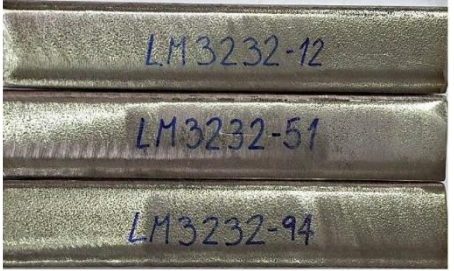
PHOTOGRAPHS	
Solution A	Solution B
LM3124- 20// 57 // 90, sample surface as received	LM3232 - 12 // 51 // 64, sample surface as received

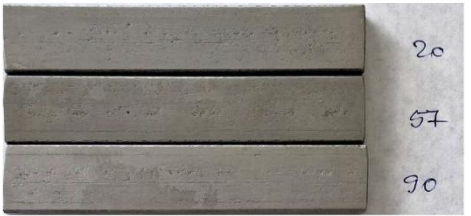
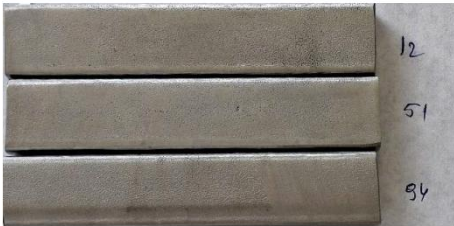
Surface pattern after NACE TM 0284 test	Surface pattern after NACE TM 0284 test

OBSERVATIONS
<p>The initial pH of the NACE B solution was 8.16. After the saturation in H₂S the pH was 5.10 and at the ending of test was 5.37. Alumina (Al₂O₃) suspension of 0,3 µm was used to prepare by polishing the samples surfaces up to mirror brightness before optical microscope investigation. The samples tested in NACE solution B before microstructure analysis were not etched. They were investigated on surfaces wiped with alcohol and dried.</p> <p>Vertical filiform corrosion in the form of putting lines is observe don the Surface of sample LM 3232 – 51. This type of filiform corrosion looks groove and is not a typical HIC crack. The active corrosion head is round and not sharp as in the case of typical HIC cracking in steps.</p> <p>On sample LM 3232- 94, to initiations of horizontal filiform corrosion are observed.</p>

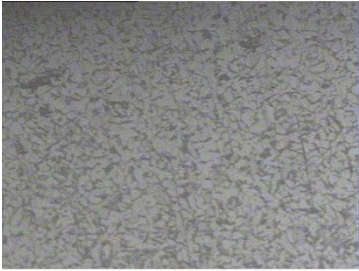
LM3124-20	LM3232-12
Microstructure of sample 20 Magnification x 100	Microstructure of sample 12 Magnification x 100

OBSERVATIONS
Alumina (Al ₂ O ₃) suspension of 0,3 µm was used to prepare by polishing the samples surfaces up to mirror brightness before optical microcope investigation. The samples tested in NACE solution A before microstructure analysis were etched with Nital solution (5 ml HNO ₃ : 95 ml etanol) for 15 seconds.

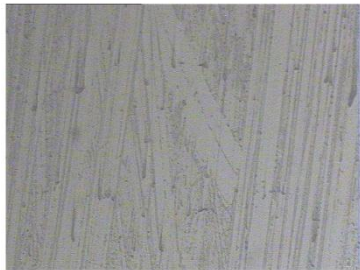
Microstructure of sample 20 Magnification x 200	Microstructure of sample 12 Magnification x 200

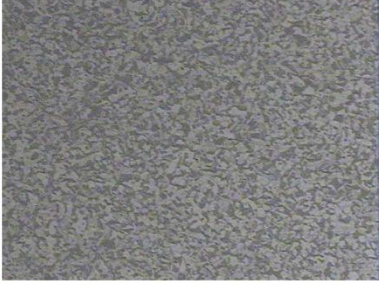
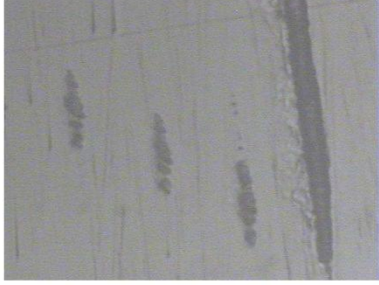
LM3124- 57	LM3232-51
Microstructure of sample 57 Magnification x 100	Microstructure of sample 51 Magnification x 100

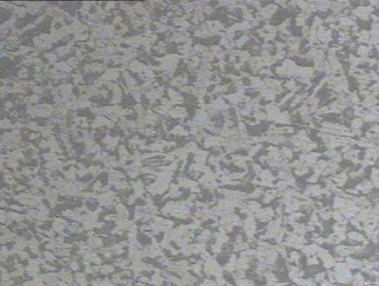
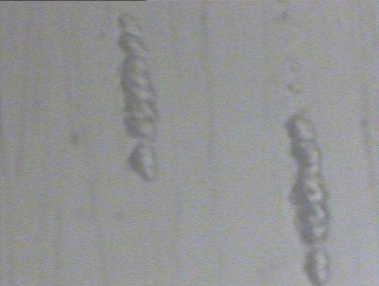
Microstructure of sample 57 Magnification x 200	Microstructure of sample 51 Magnification x 200

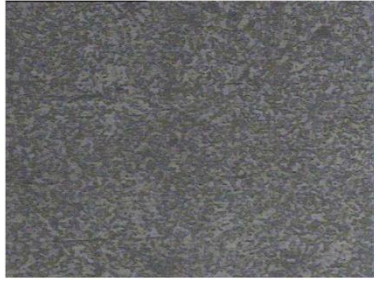
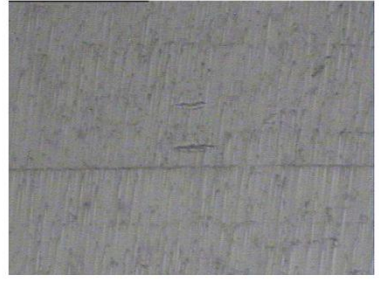
LM3124-90	LM3232-94
Microstructure of sample 90 Magnification x 100	Microstructure of sample 94 Magnification x 50

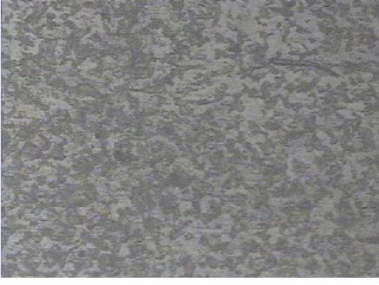
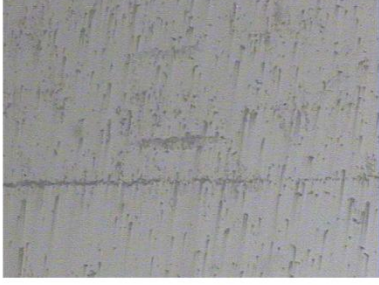
Microstructure of sample 90 Magnification x 200	Microstructure of sample 94 Magnification x 100
