REPORT No 11291

NACE TM 0284

EVALUATION OF PIPELINE AND PRESSURE VESSEL STEELS FOR RESISTANCE TO HYDROGEN-INDUCED CRACKING

Program: SQO-M4 Round 17

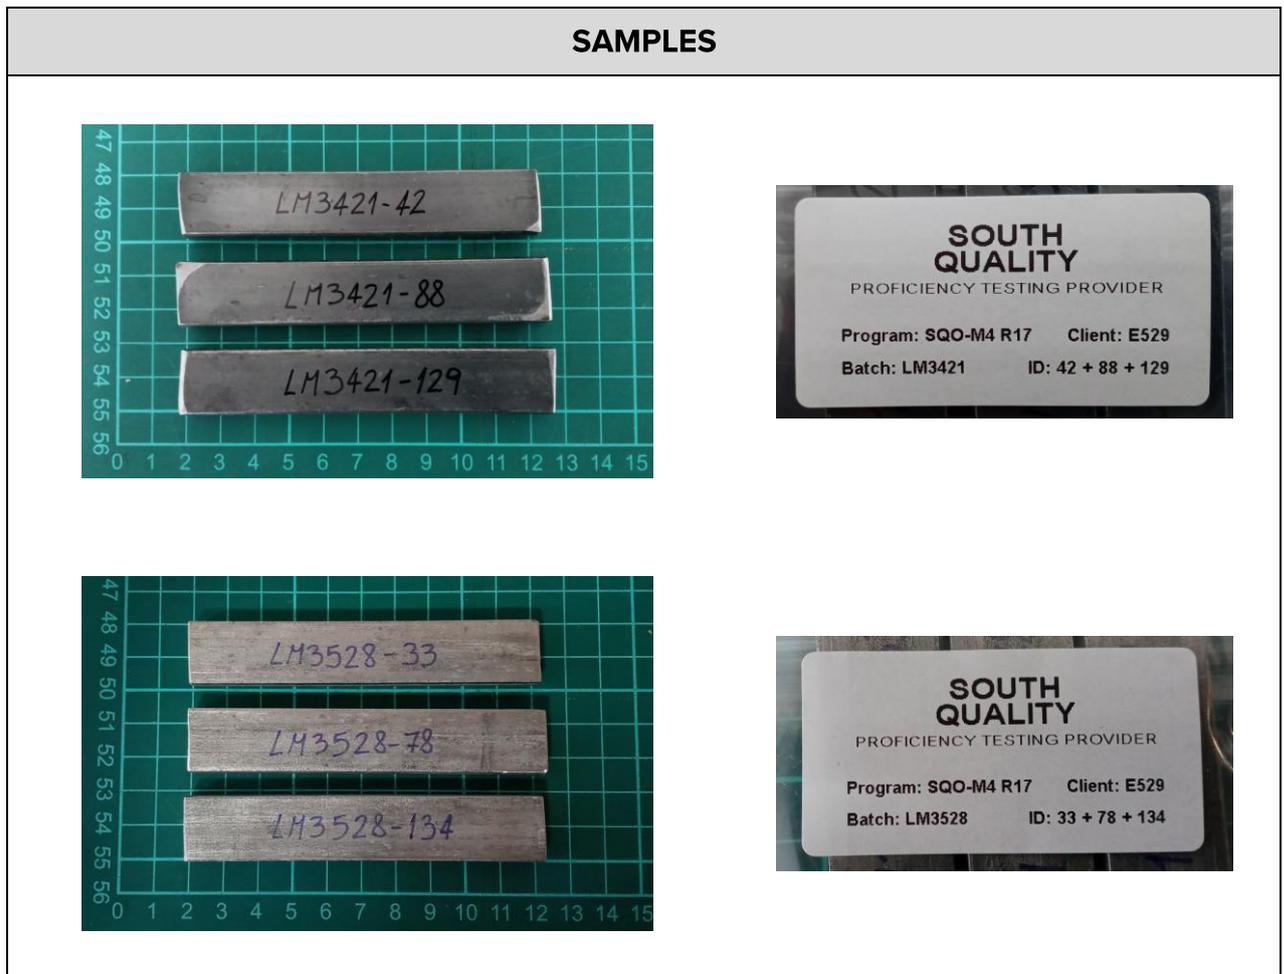
7. IMAGES

Batch:	LM3421
Sample ID:	42 + 88 + 129
Characteristics:	Carbon steel (SAE 1010) - 100 x 19.1 x 9.5 mm

Batch:	LM3528
Sample ID:	33 + 78 + 134
Characteristics:	Stainless steel (AISI 304) - 100 x 19.1 x 9.5 mm
